RCRA FACILITY ASSESSMENT REPORT  
FOR  
DICO OIL CORPORATION

EPA ID NO. CAD980737076

JUNE 1994

PREPARED BY:  
CALIFORNIA ENVIRONMENTAL PROTECTION AGENCY  
DEPARTMENT OF TOXIC SUBSTANCES CONTROL  
1011 NO. GRANDVIEW AVENUE  
GLENDALE, CALIFORNIA 91201

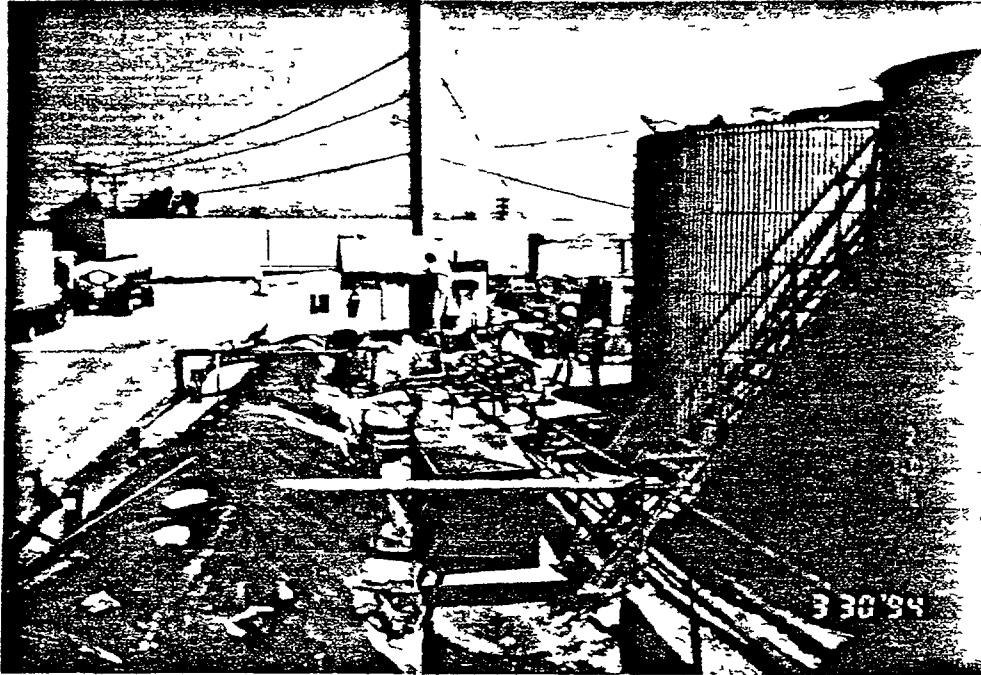
Photograph No. 3 This is a view of the facility looking North. Notice the tank farm has no secondary containment and the soil appears to be stained.

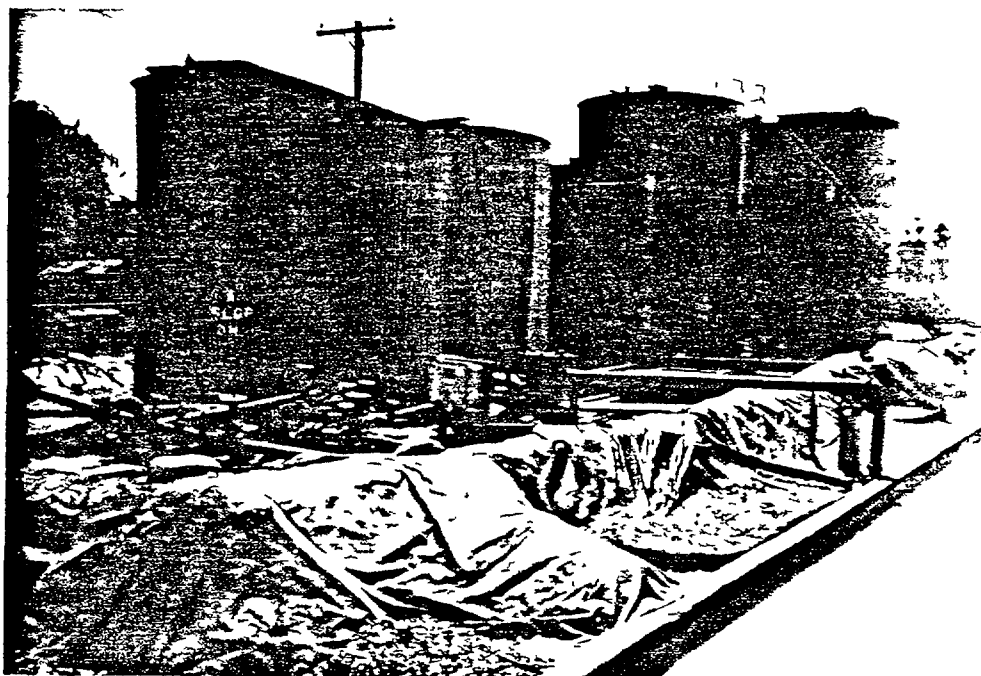
Photograph No. 5 This photograph contains Process/Storage tanks: T1-T4, TA5 and TB. Notice the tank farm contains no secondary containment and the Berm is composed of soil covered with visquene.

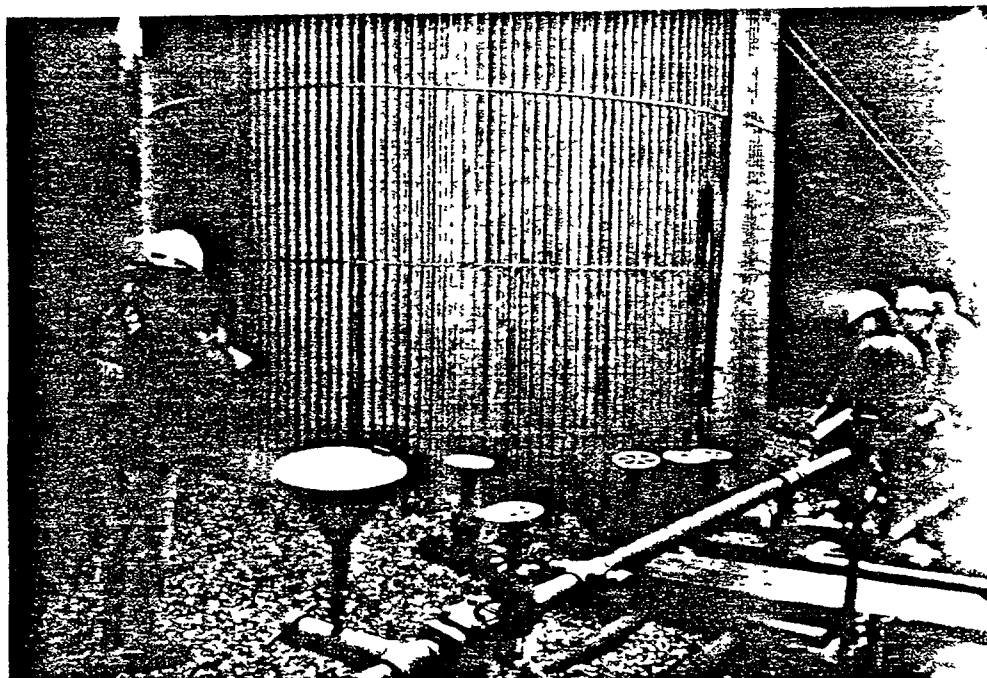
Photograph No. 6 This photograph is a close up of Process/Storage tank T1 (SWMU No. 1). This tank is insulated but has not been in use for over 15 years.

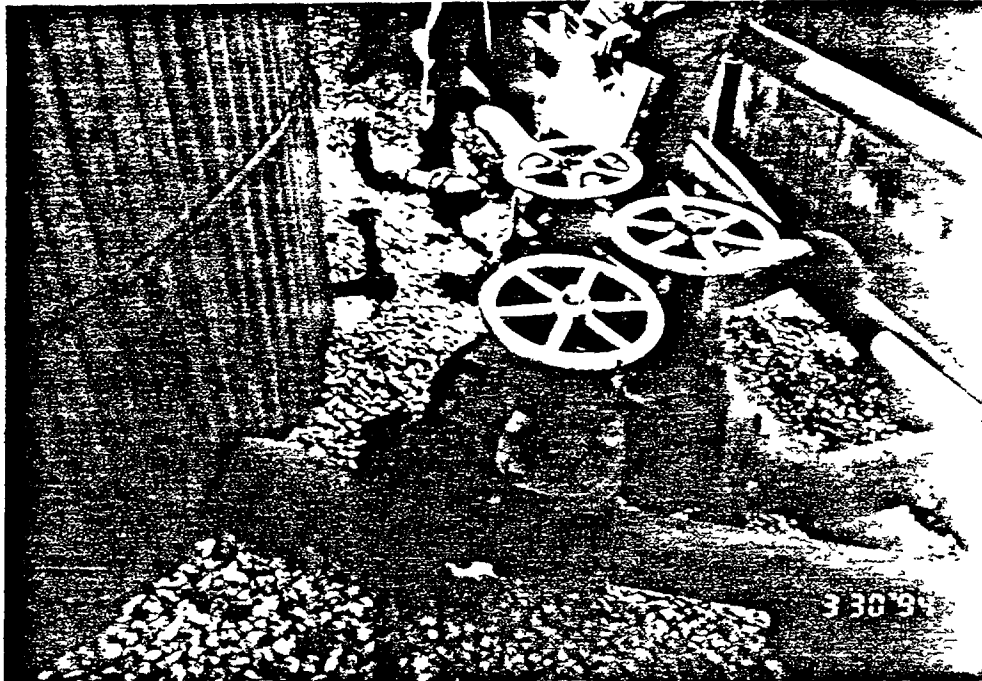
Photograph No. 7 This is a photograph of the associated piping for Process Tank T1 (SWMU No. 1). Notice the oil stains on the gravel next to the piping.

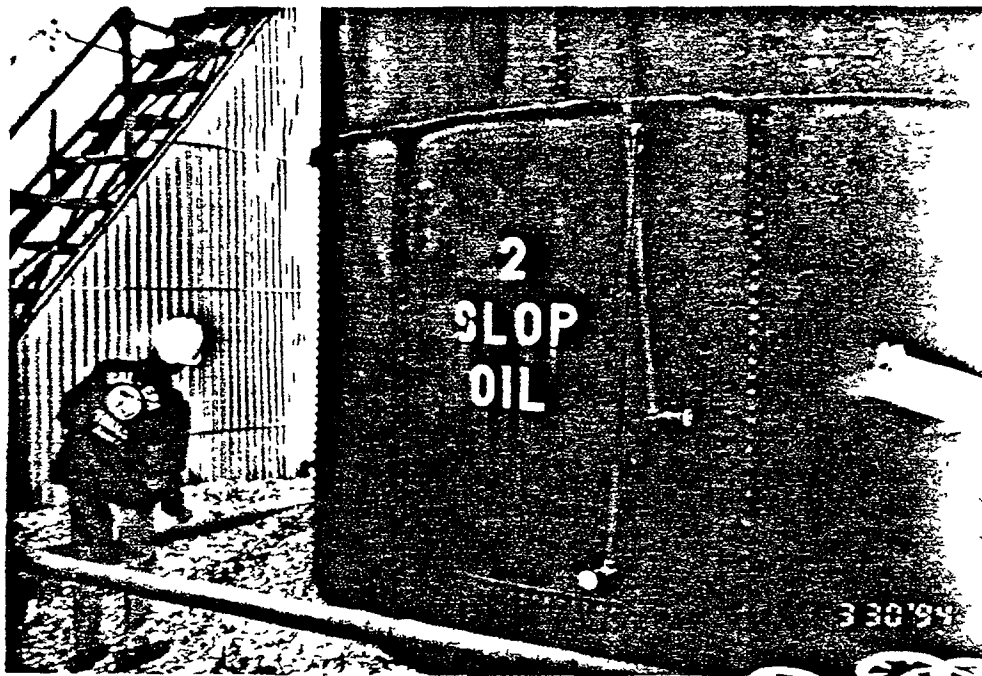
Photograph No. 8 This is a close up of Process/Storage Tank T2 (SWMU No. 2). Notice this a riveted tank which has corrosion and is over 40 years old. The tank farm has no secondary containment

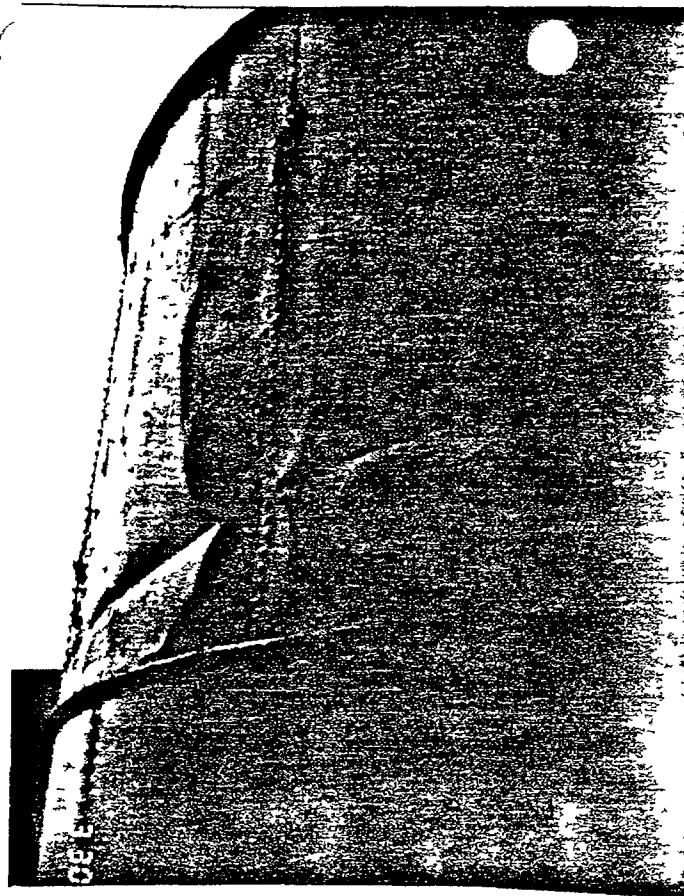
Photograph No. 9 This is a close up of Process/Storage Tank T2 (SWMU No. 2). This tank is currently operating. Notice the buckling and poor condition of this riveted tank.

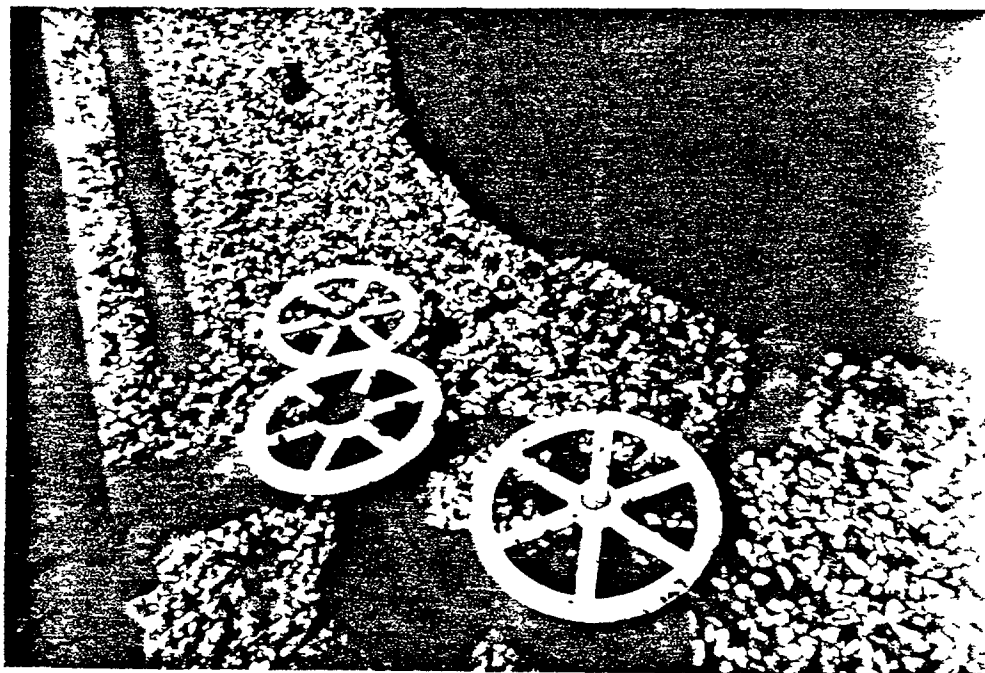
Photograph No. 10 This is a close up of the associated piping for Process/Storage Tank T2 (SWMU No. 2). Notice the oil stains on the gravel due to leaks.

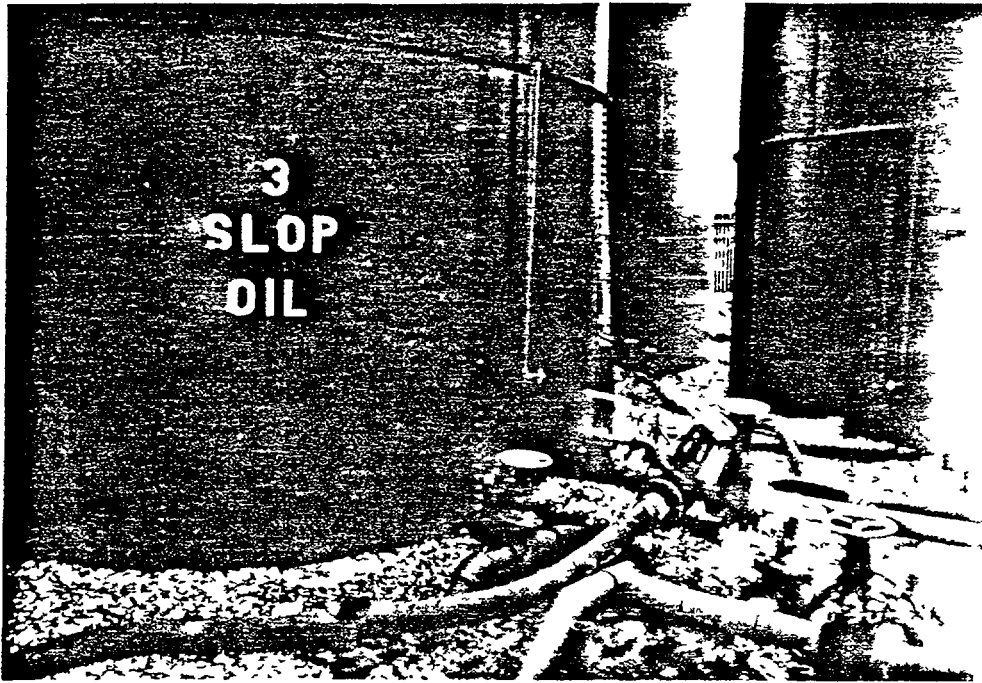
Photograph No. 11 This is a close up of Process/Storage Tank T3 (SWMU No. 3). This tank is currently operating. Notice this a riveted tank which has corrosion and is over 40 years old.

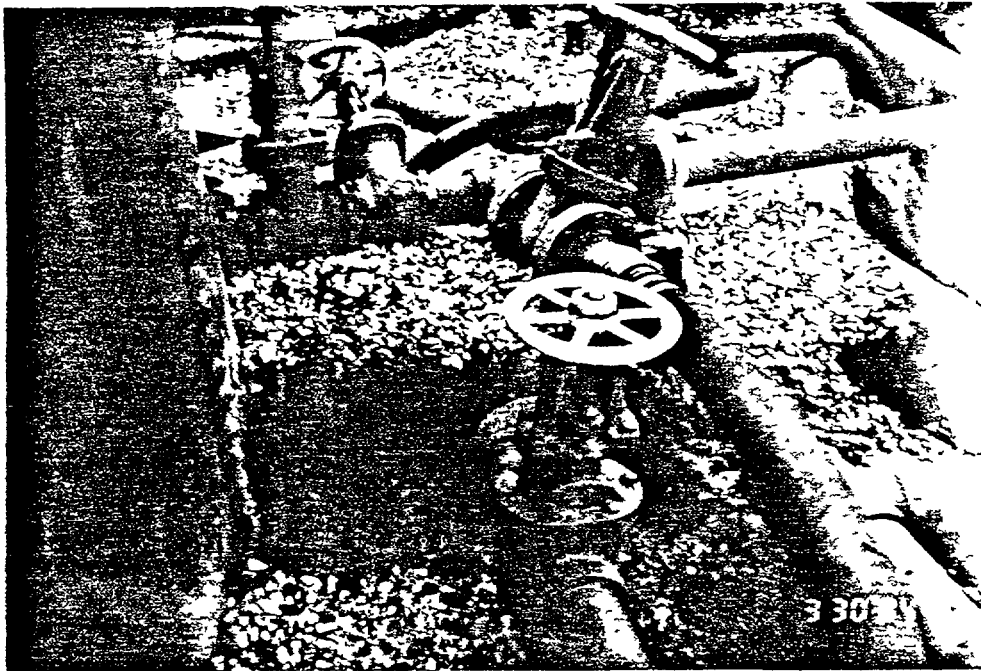
Photograph No. 12 This is a close up of the associated piping for Process/Storage Tank T3 (SWMU No. 3). Notice the oil stains on the gravel due to leaks.

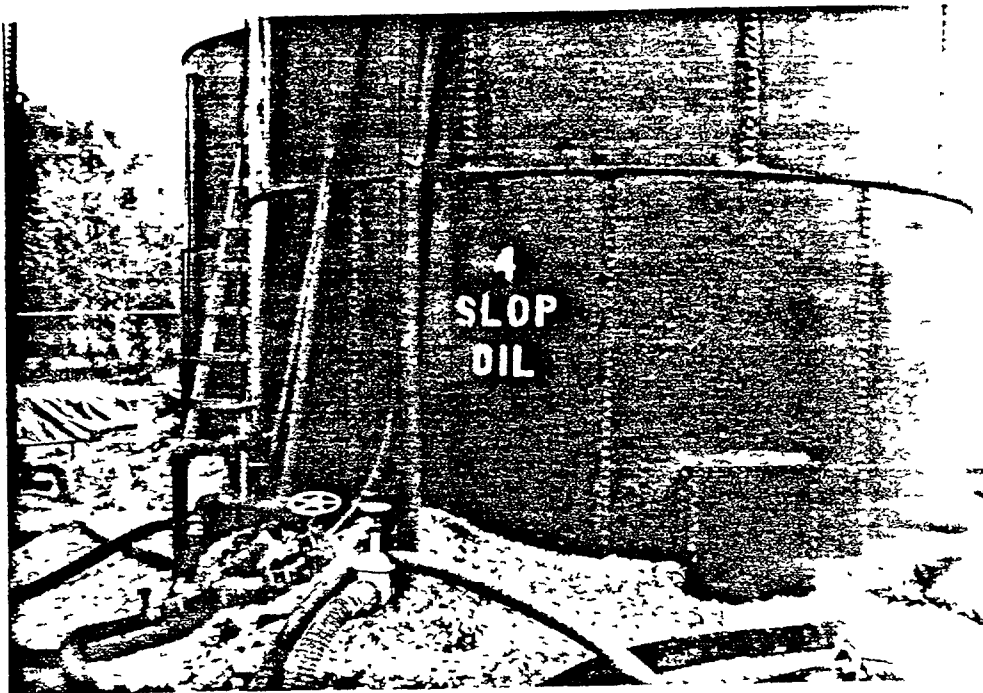
Photograph No. 13 This is a close up of Process/Storage Tank T4 (SWMU No. 4). This tank was currently operating the day of the inspection. It was discovered to be leaking and was subsequently taken out of service.

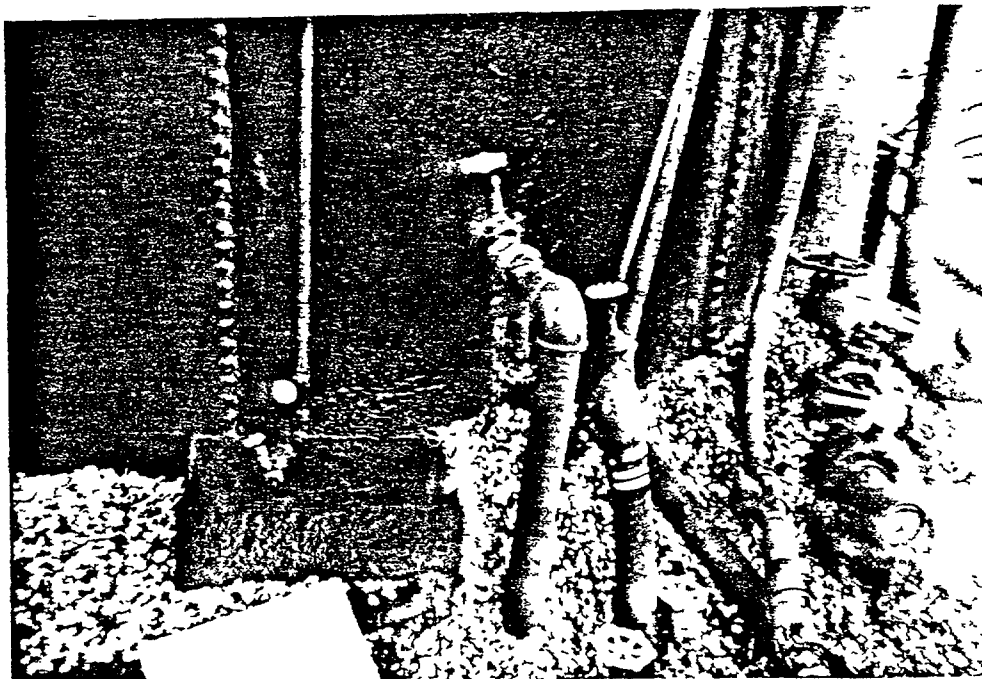
Photograph No. 14 This is a close up of the associated piping for Process/Storage Tank T4 (SWMU No. 4). Notice the oil stains on the gravel due to leaks.

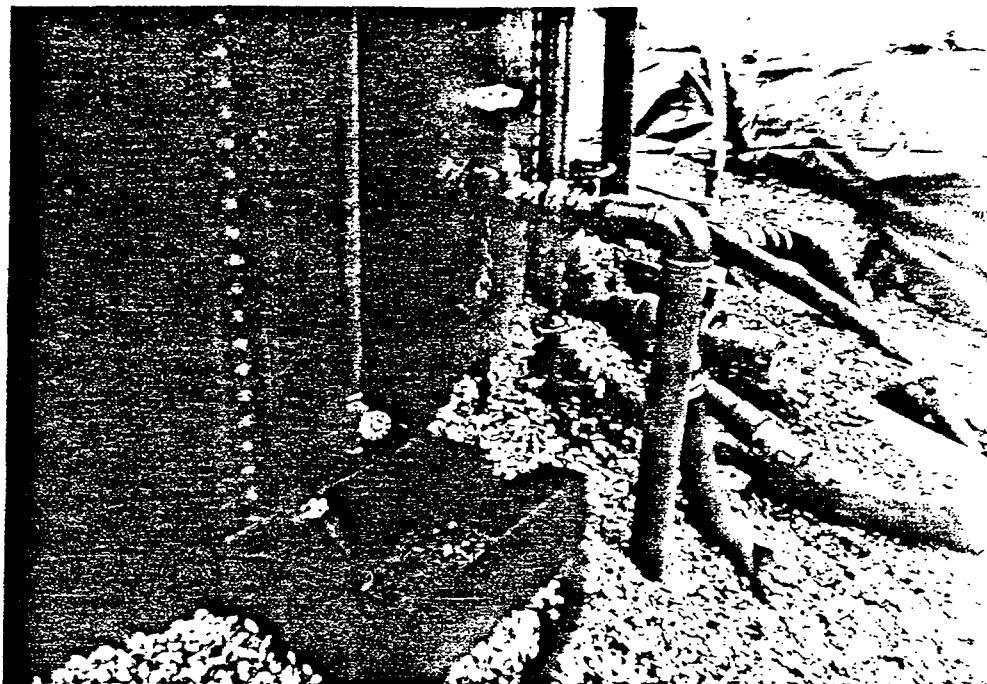
Photograph No. 15 This is a close up of the associated piping for Process/Storage Tank T4 (SWMU No. 4). Notice the oil stains on the gravel due to leaks.

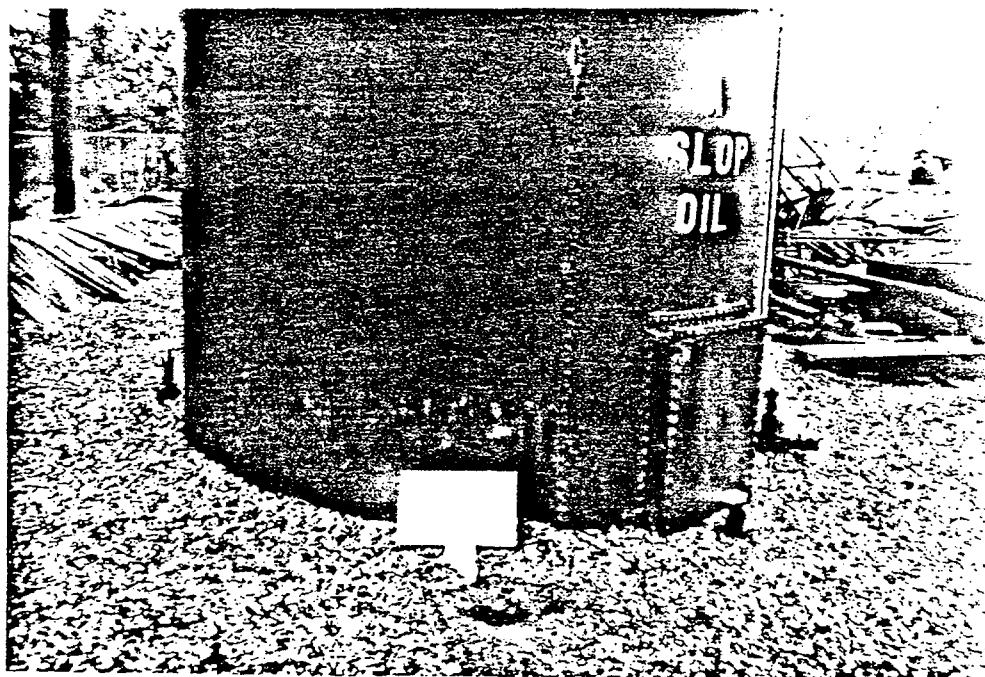
Photograph No. 16 This is a photograph of Process/Storage Tank TA5 (SWMU No. 5). This tank failed in 1992. This a riveted tank which has severe corrosion and is over 40 years old.

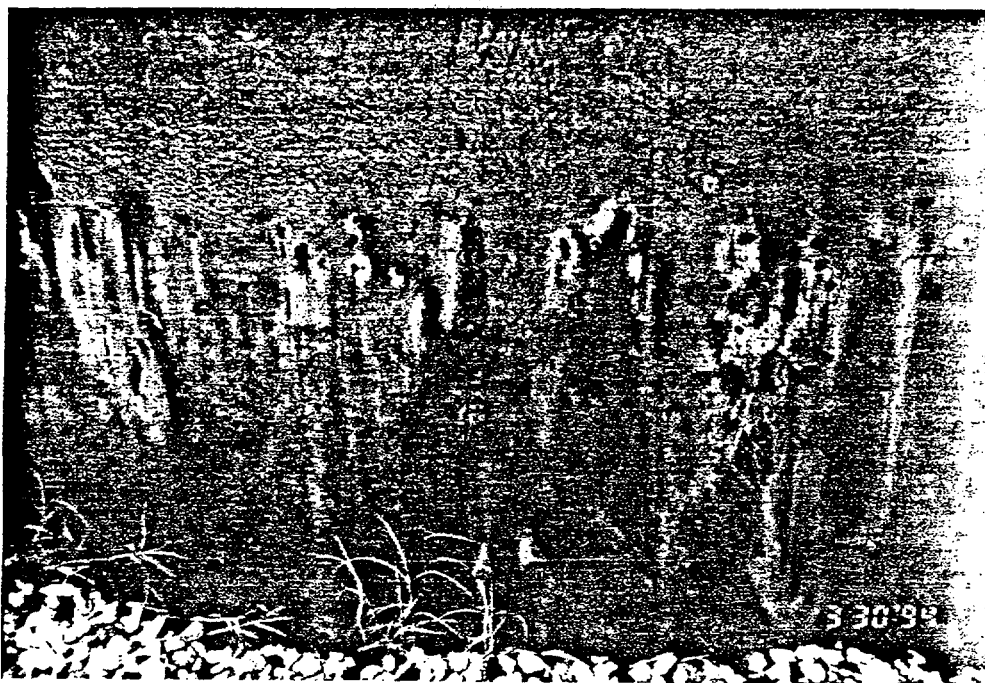
Photograph No. 17 This is a close up of Process/Storage Tank TA5 (SWMU No. 5). Notice the severe corrosion of the tank. Notice the tank had several holes that contained plugs around the base.

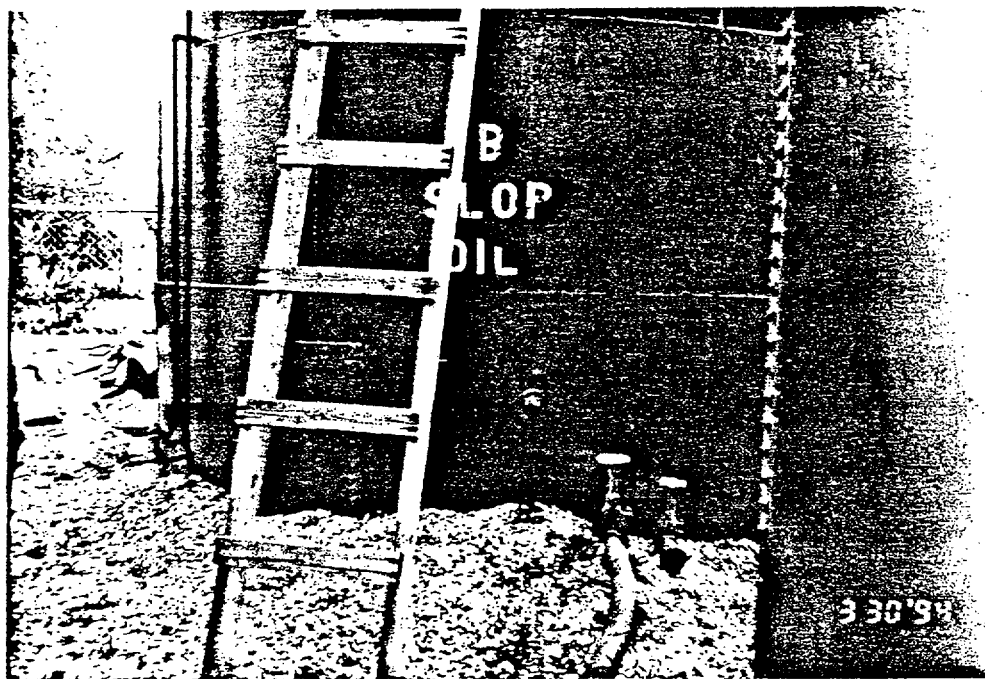
Photograph No. 18 This is a photograph of Process/Storage Tank TB (SWMU No. 6). This a riveted tank and has corrosion and is over 40 years old. Notice the oil stains on the gravel near the piping.

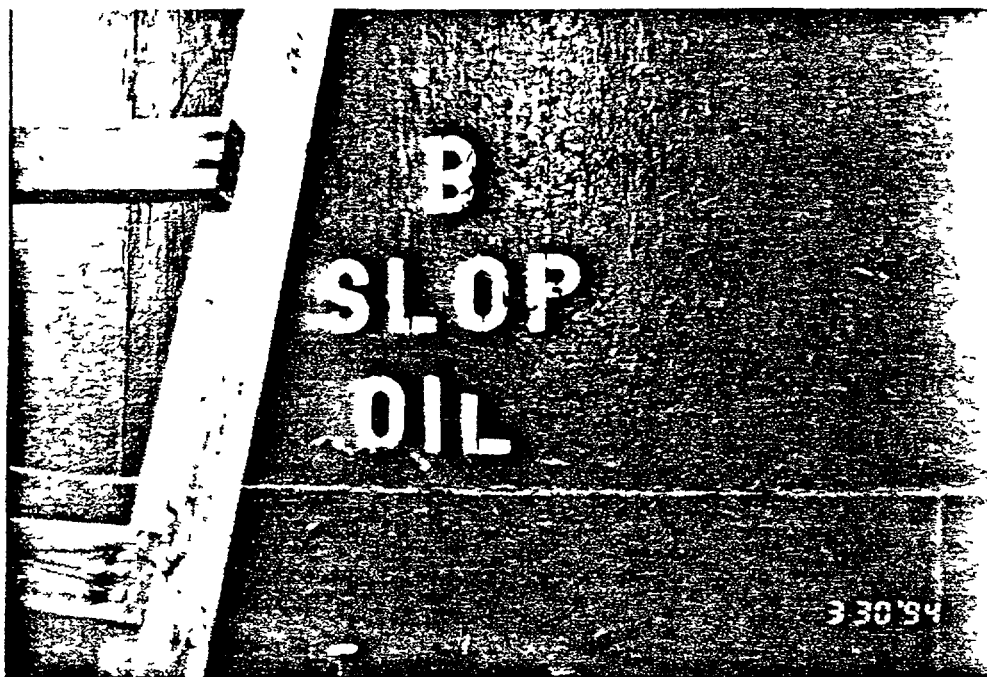
Photograph No. 20 This is a close up of Process/Storage Tank TB (SWMU No. 6). Notice the cracks in the tank.

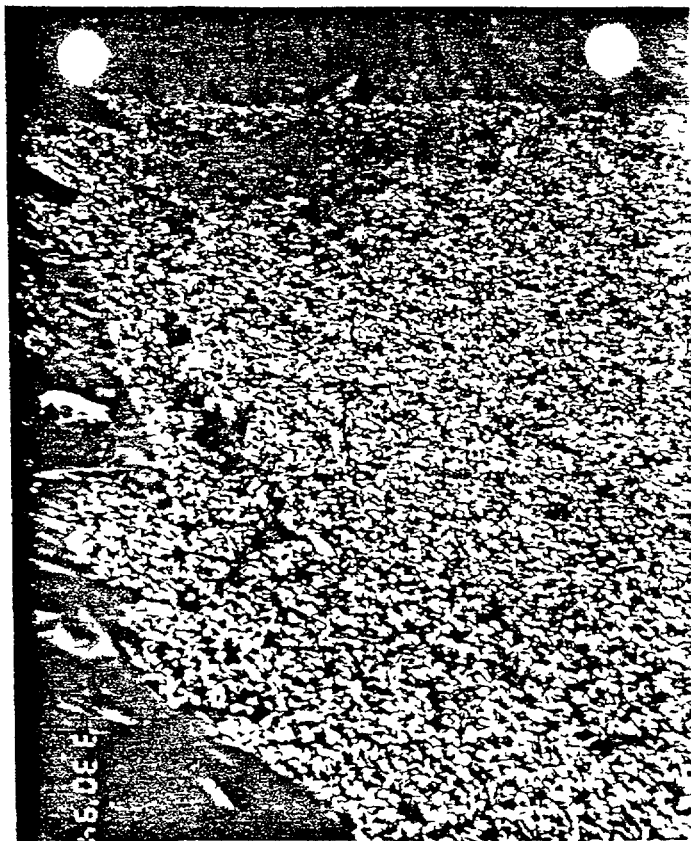
Photograph No. 21 This is a photograph of the Tank Pit Areas No. 1 and No. 2. (SWMU No. 8 & 9 respectively). This area previously contained two underground storage half tanks that were removed due to leaks.

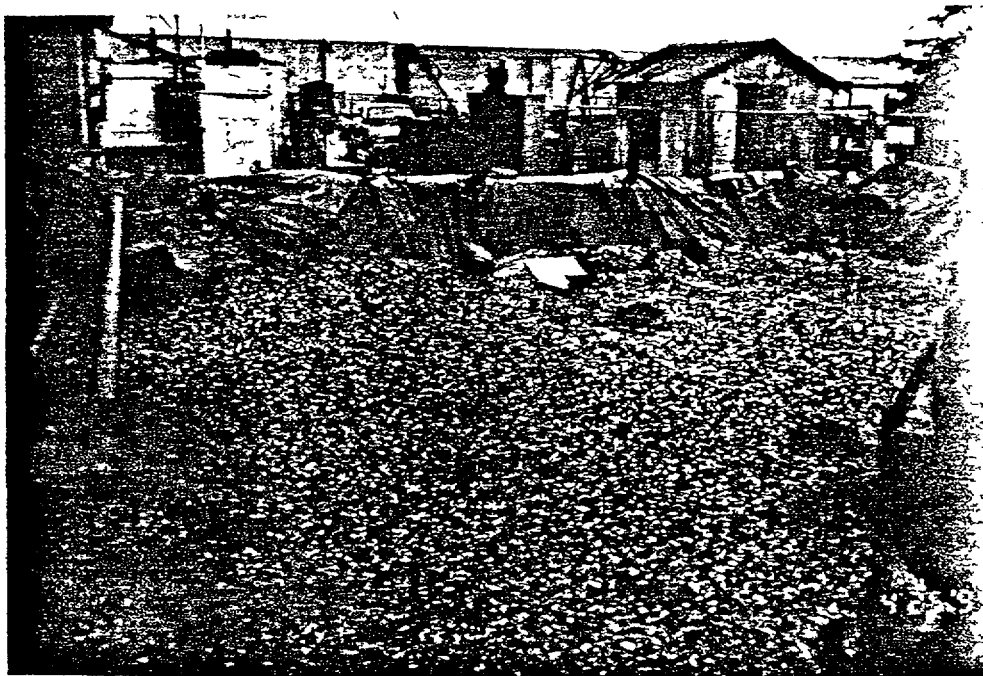
Photograph No. 22 This is another view of the Tank Pit Areas No. 1 and No. 2. (SWMU No. 8 & 9 respectively). This area contained soil that appeared to be fill, there were few visible stains of oil.

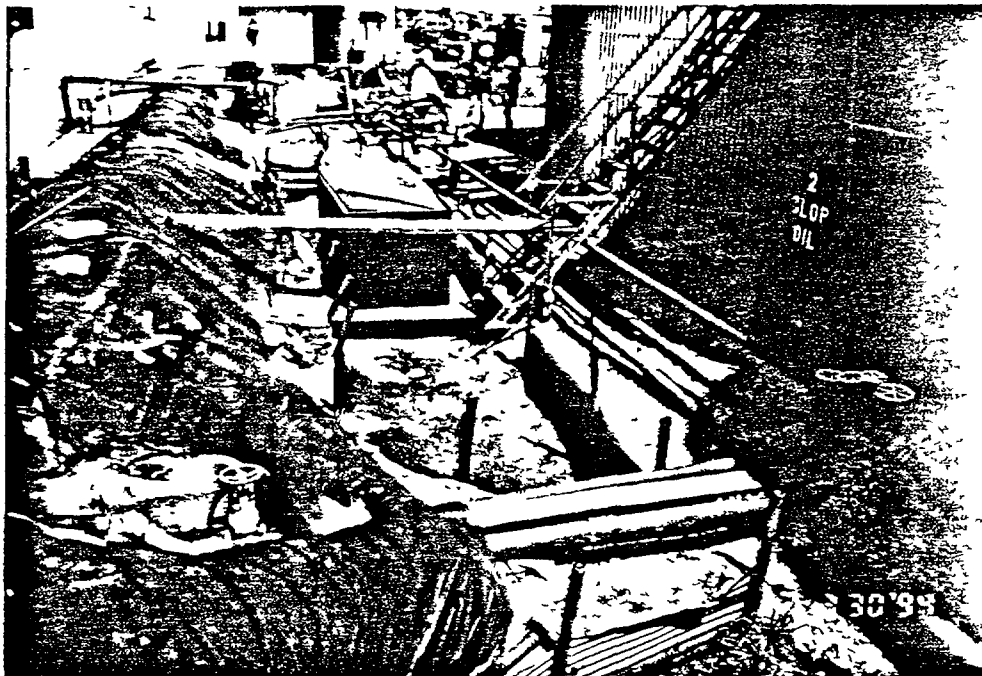
Photograph No. 24 This is a another view of the Trench area contained within the tank farm (SWMU No. 10). Notice there is no cement berm contained around this area.

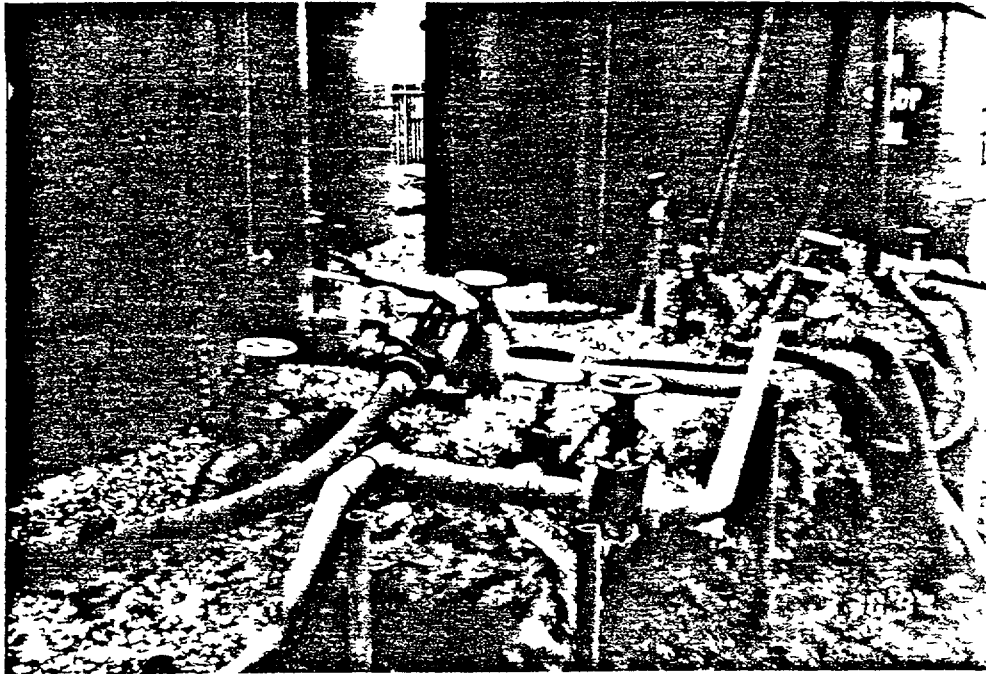
Photograph No. 27 This is a photograph of the associated piping system within the Trench area (SWMU No. 14) . Notice the dark and oily discoloration of the soil due to leaks.

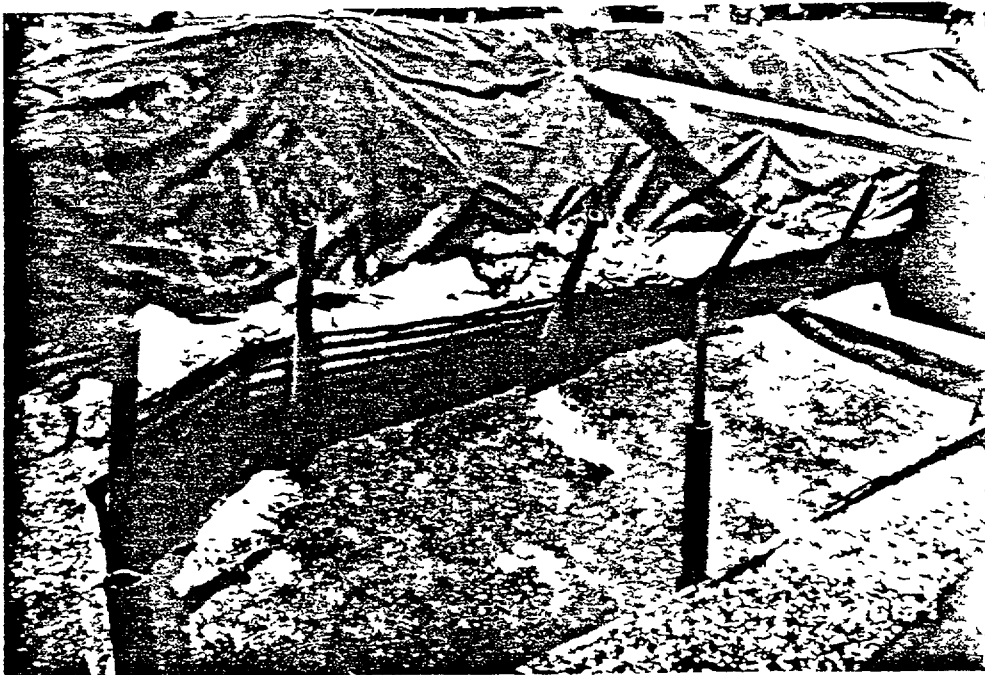
Photograph No. 28 This is a photograph of another section of the Trench area (SWMU No. 10) . Notice the dark and oily discoloration of the soil and the lack of proper secondary containment within the trench farm area.

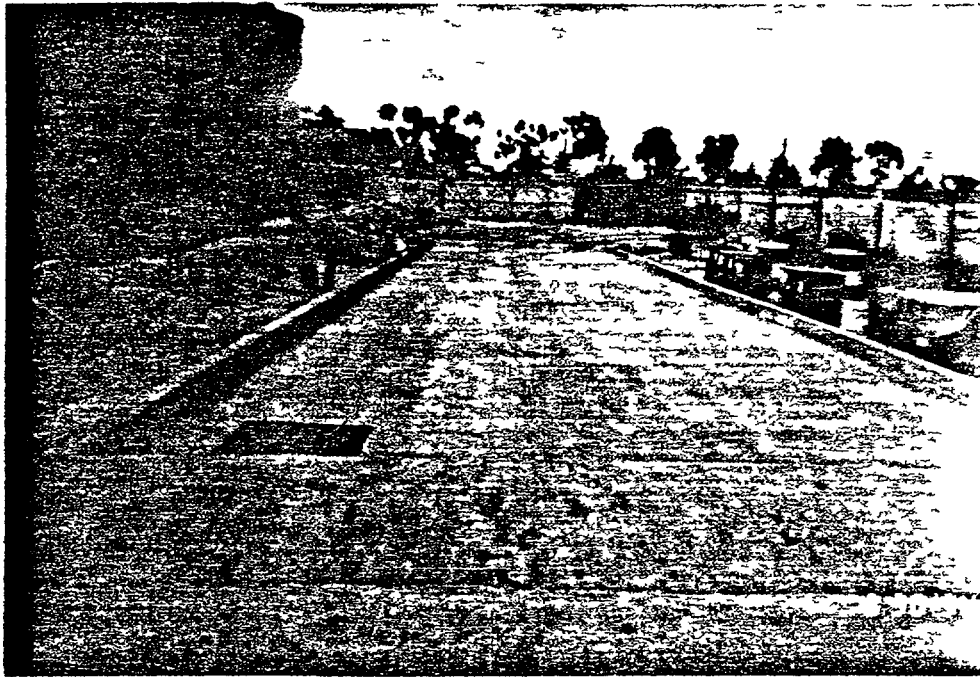
Photograph No. 33 This is a photograph of the Truck Loading/Unloading area within the facility (SWMU No. 12). This view is looking south. Notice the stains of oil on the cement.

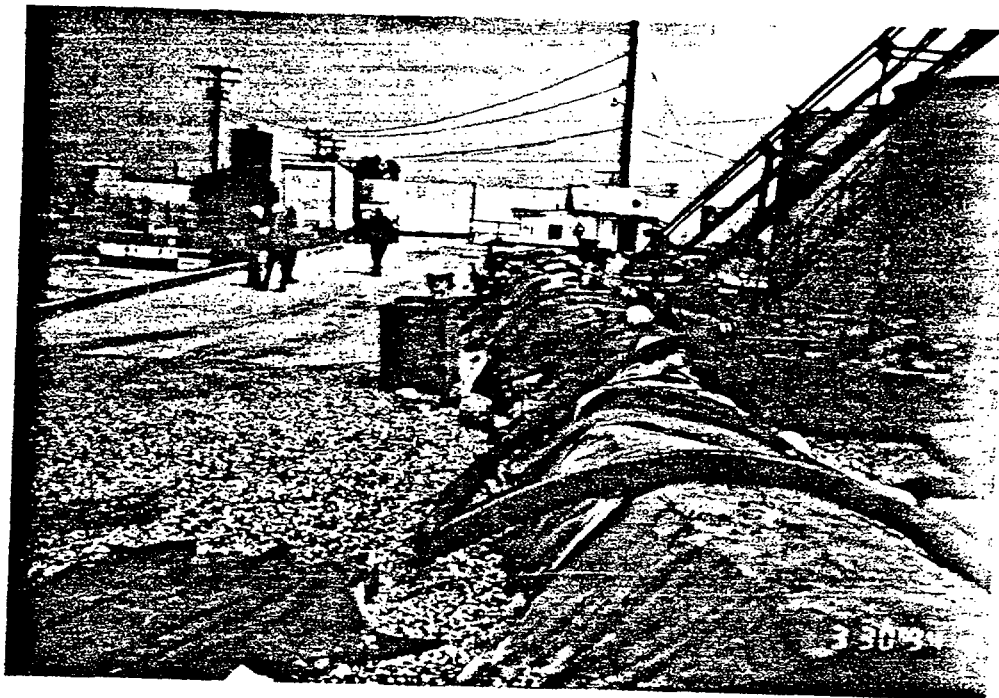
Photograph No. 35 This is another view of the Truck Loading/Unloading area within the facility (SWMU No. 12). This view is looking north. Notice the area is not paved down to the end of the facility.

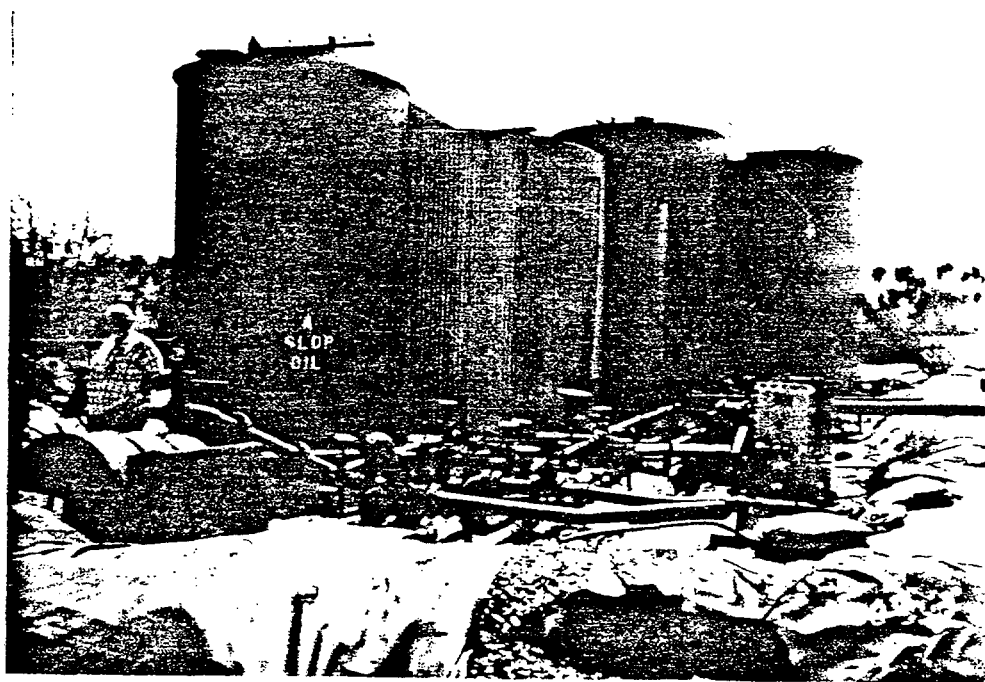
Photograph No. 36 This is a photograph of the associated piping system within the facility (SWMU No. 14). The piping is color coded for identification purposes. Notice the lack of proper containment for the pipes.

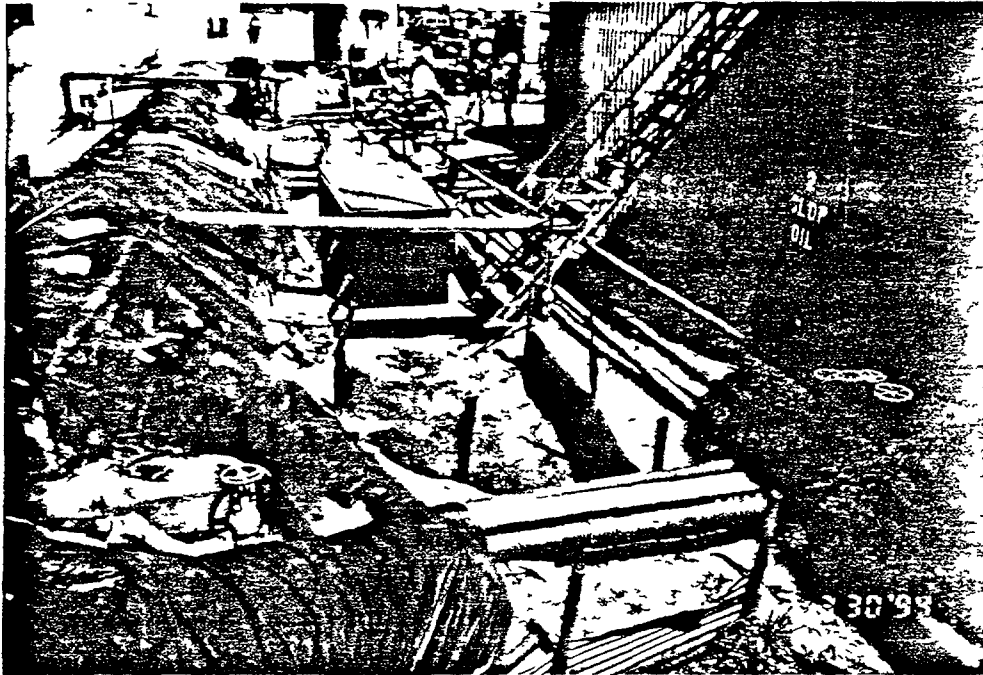
Photograph No. 37 This is another view of the piping system within the facility (SWMU No. 14). This view is looking north. Notice the lack of proper containment for the pipes.

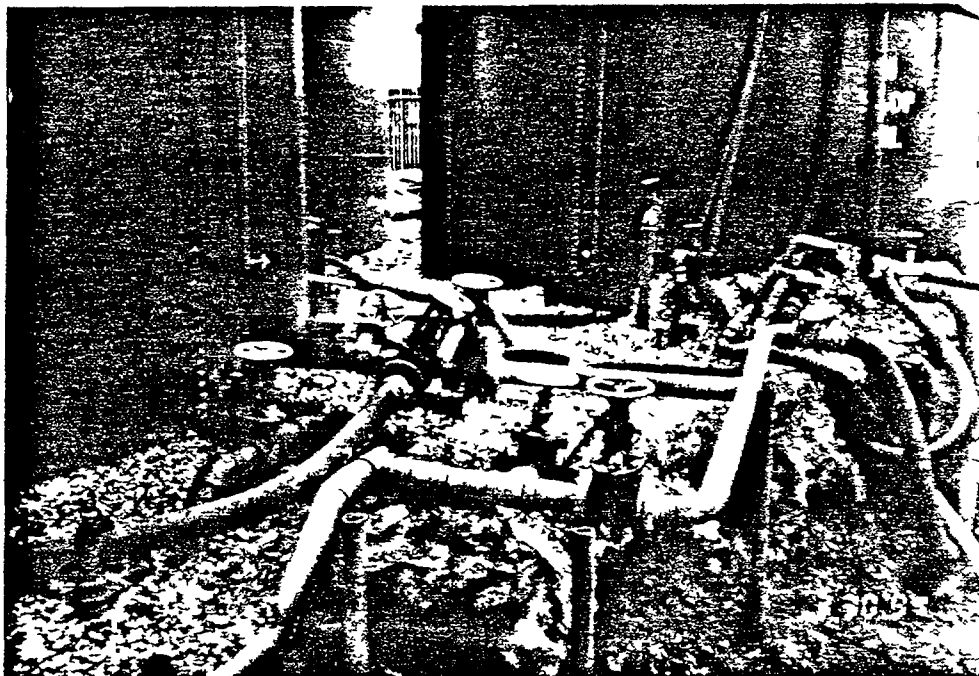
Photograph No. 38 This is a close up view of the piping system near tanks T3 and T4 (SWMU No. 14). Notice the lack of proper containment for the pipes.

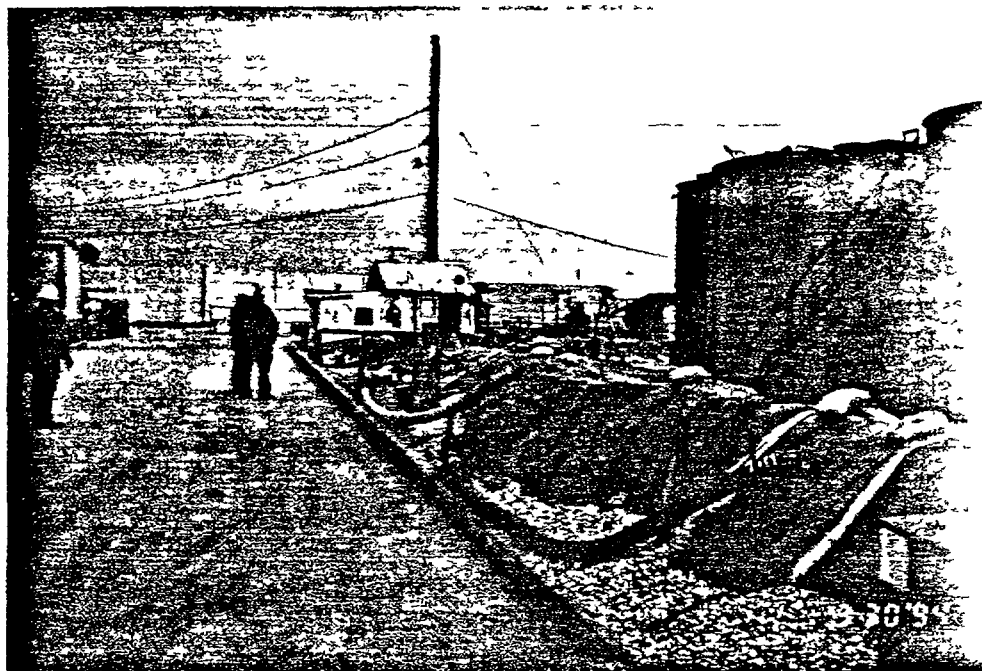
**Photograph No. 39** This is another view of the loading/unloading area. The vacuum pumps are used to load and off load waste oil within the tanks contained within the tank farm (SWMU No. 12). Notice the lack of proper containment.

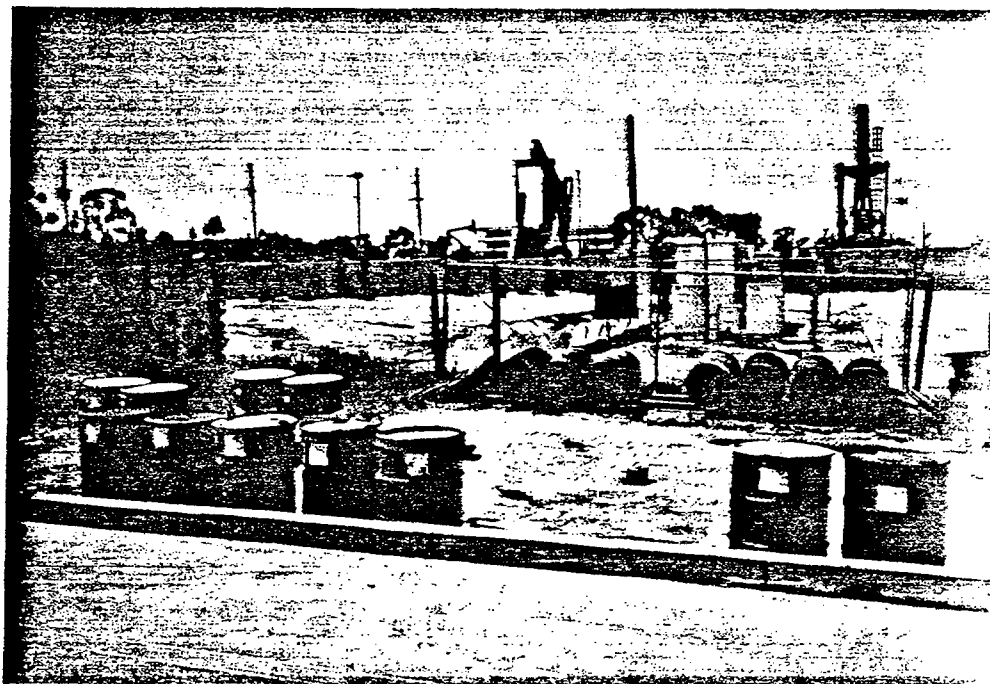
Photograph No. 41 This is a photograph of the Drum Storage area (SWMU No. 15). This area has a partial cement pad floor. Notice the cement pad does not extend to end of facility boundary.

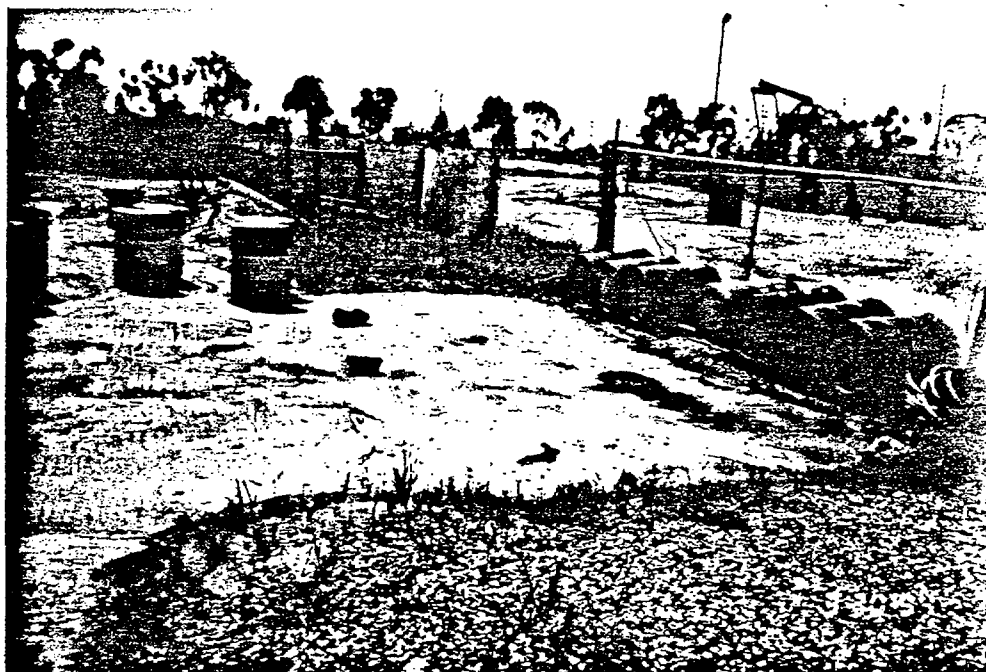
Photograph No. 42 This is a close up view of the Drum Storage area (SWMU No. 15). This area has a partial cement pad floor. Notice the cement pad does not extend to end of facility boundary.

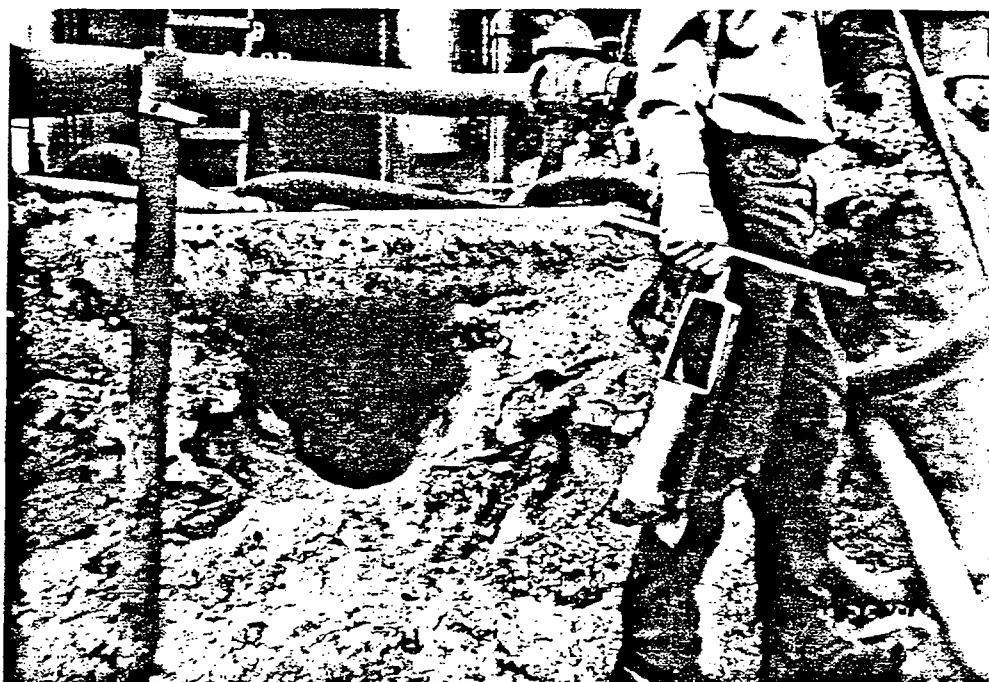
Photograph No. 47 This is a photograph of the area that had a documented release of polychlorinated biphenyl (PCBs) (SWMU No. 17 & 18). This area is near tanks T3 and T4. Notice the dark and oil stained soil.

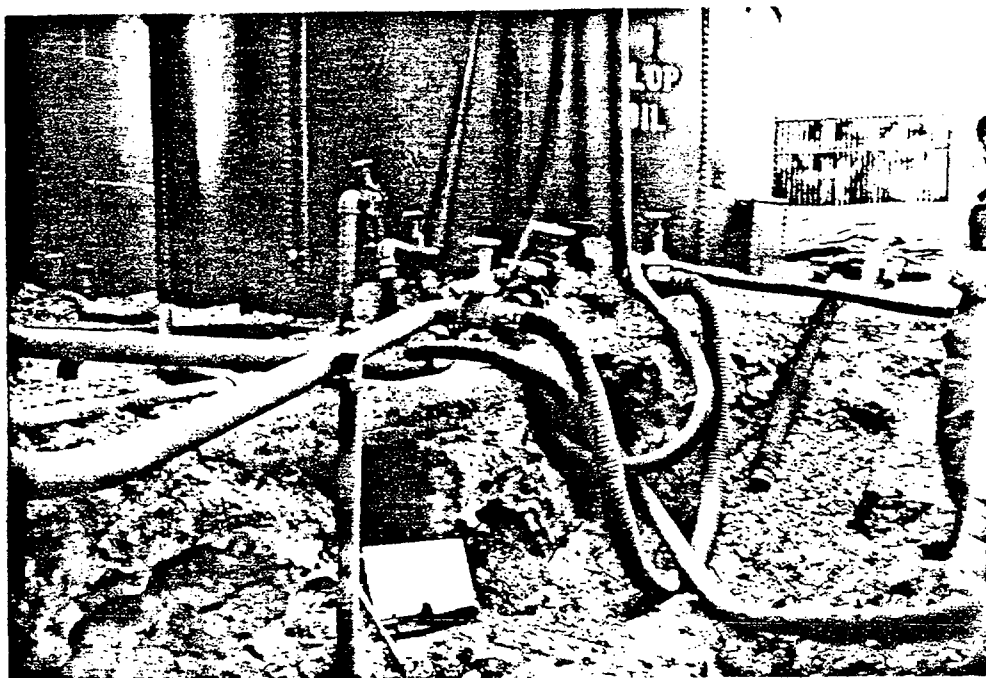
Photograph No. 48 This is another view of the area that had a documented release of polychlorinated biphenyl (PCBs) (SWMU No. 17 & 18). This area is located within the trench near tanks T3 and T4. Notice the dark and oil stained soil.

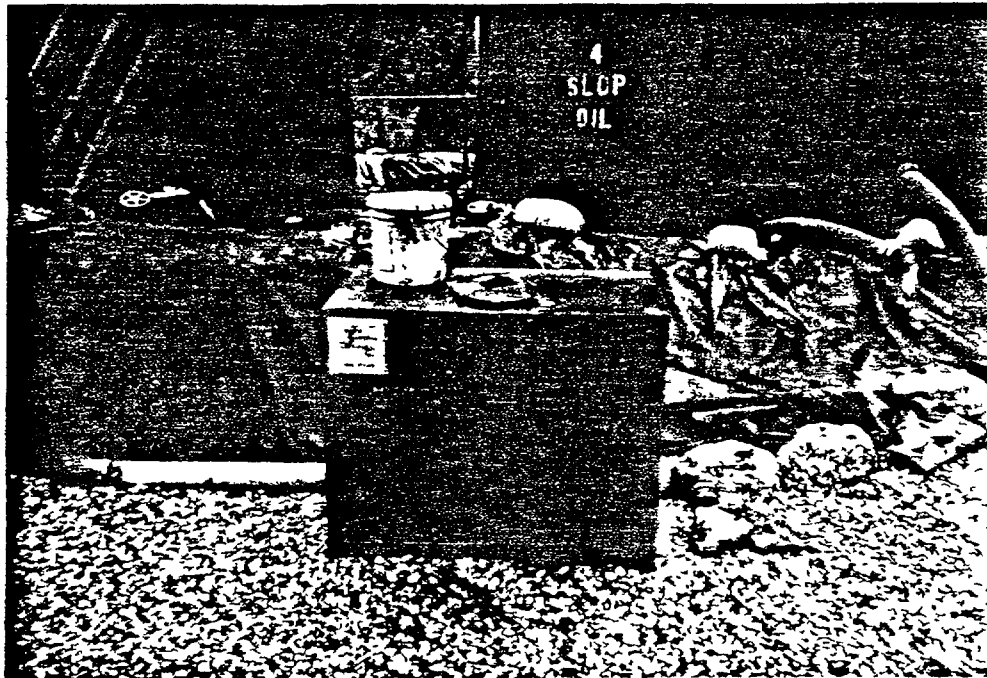
**Photograph No. 51** This is a photograph of a 110 gallon tank used for oil storage from spills that may occur during Loading/Unloading area within the facility. Notice the oil stains on the gravel beneath the tank which lacks proper containment.
